LESSONS LEARNED FROM THE XCALAK VILLAGE HYBRID SYSTEM: A SEVEN YEAR RETROSPECTIVE

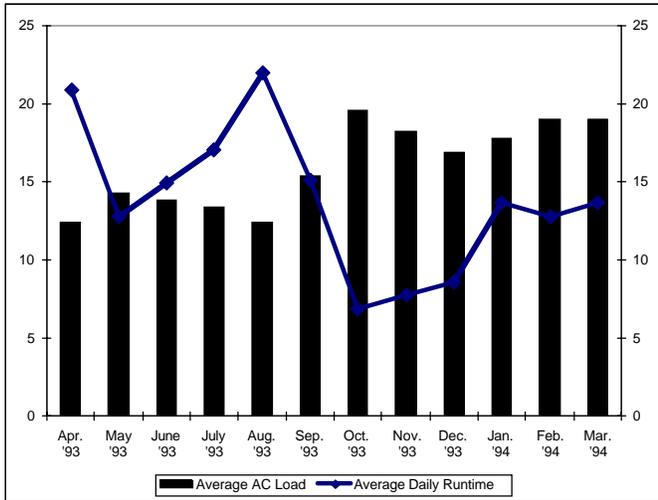
Figure 4 shows the average daily instantaneous load and average daily inverter runtime by month for the first year of operation. The average daily instantaneous power load in April 1993 was 12.4 kW, and the inverter was on an average of 21 hours per day. This means that the system provided energy production of about 260 kWh/day at that time. The daily average instantaneous power load in Xcalak increased significantly during the first 18 months of operation from 12.4 kW in April 1993 to 19 kW in March 1994, a 53% increase.

Fig. 4. Xcalak monthly load growth (kW) and average daily runtime (hrs/day) during 1993-94.

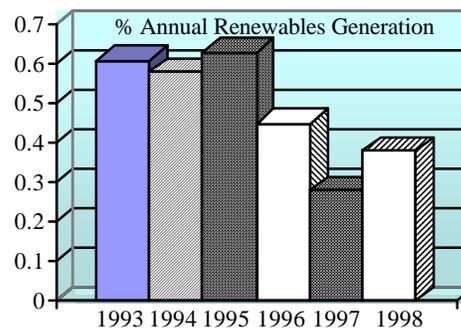
As hybrid system maintenance issues were ignored, the renewable energy production of the system decreased. The actual percentage of time that the renewables portion of the electric system provided power from 1993-98 is shown in Figure 6. During the first three years of operation, the diesel generator was never used. The increase in generation from 1997 over 1998 is due to UQROO maintenance efforts.

Fig. 6. Annual percentage of time that the renewables hybrid system powered the Xcalak community from 1993-98.

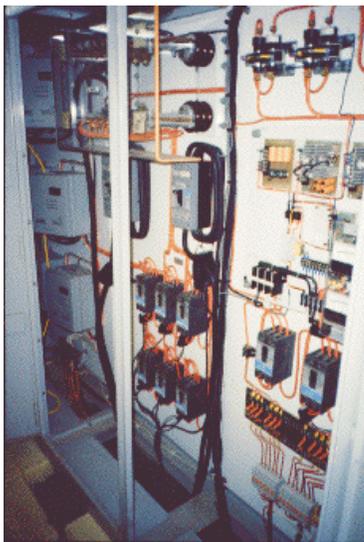
The Xcalak hybrid system is located in one of the most challenging tropical salt spray environments in the world. The system itself lies a mere 100 meters from the water's edge. This unforgiving salt spray environment is a challenge for any piece of hardware to survive. A maintenance infrastructure in such a harsh environment is absolutely critical, however no such long-term infrastructure was contemplated in the original project. Thus, many of the hybrid system components have suffered from a general lack of maintenance and have degraded over time. While some ad hoc attempts by UQROO, AWEA, CFE, and others have been made to conduct occasional repairs, there has been no consistent maintenance program for the system and no responsible party for conducting such maintenance.

Fig. 7. System disconnects and controllers for the PV array (foreground) and wind turbines (rear).

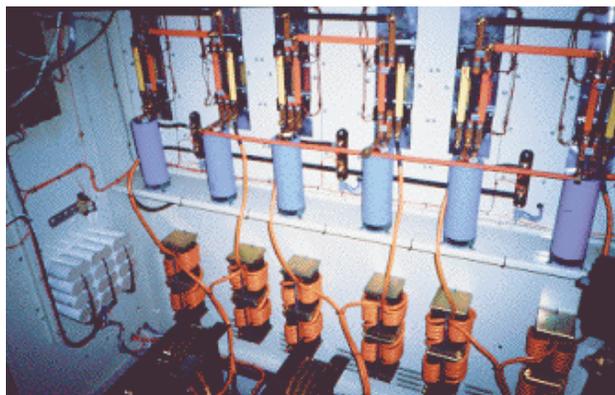
The AES inverter has faced a difficult job in Xcalak with highly unbalanced system loads due the use of a few large distribution transformers - thus restricting optimal phase balancing. These conditions have caused the inverter to suddenly disconnect at times. The inverter literally baked some of the its wire insulation, which was later replaced. Failed inverter fans caused overheating and significant corrosion of internal inverter components. Inverter corrosion was further exacerbated by

drawing humid air from below ground concrete raceways. Some of the inverter analog meters have not functioned well.

Fig. 8 40 kW Xcalak inverter.

The inverter has had four major failures since installation where the insulated gate bi-polar transistors (IGBT's) have blown due to surges, mostly related to area lightning events. Three times the electronic circuit boards have been repaired or replaced, and the inverter has not been functional since the fall of 1998 due to a failure in the controller cards during a lightning event. The inverter manufacturer has promised to repair and upgrade the inverter, but has not yet set a final date for this intended repair. There is no one locally capable of conducting this repair. Presently all renewable energy generated by the wind turbines and the photovoltaic system is lost due to the inoperative inverter. All power to the community is currently provided by the diesel generator, normally only operated three to four hours in the evening.

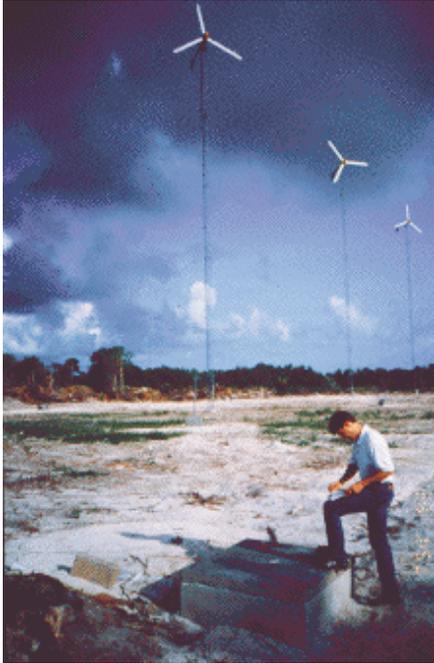
The Xcalak hybrid system includes six BWC Excel 10 kW wind turbines. No special request or specification for anti-corrosive hardware was made by the system installer. Thus, it comes as no surprise that with continual exposure to salty air, corrosion and eventual failure of the wind turbines occurred. In 1998, all six wind turbines were lowered and locally rebuilt to the best of the abilities of the UQROO.

Another aspect also not understood by the original system installer was that these wind turbines, with a 3 phase AC variable frequency output, were rectified for battery charging. Thus, held at a constant battery bank voltage, they are only capable of producing a maximum of about 7 kW of power in this configuration.

Fig. 9. Xcalak wind turbines in 1992.

Lightning has been an occasional hazard for the Xcalak wind turbines during severe storms, despite normal system grounding. One wind turbine failed about seven months after installation due to a lightning strike, and was quickly removed and repaired. Three years later, lightning once again struck and slightly damaged two turbines that were repaired locally. A third lightning storm in the fall of 1998 again took out two wind turbines and the inverter.

There have been other components that have had to be repaired, such as replacing the guy lines (the original galvanized ones had severely corroded after five years). Four turbine nose cones whose supports had rusted were replaced. The turbine tower disconnects and fuses suffered severe corrosion and were replaced in weatherproof enclosures. All of the furling winches and lines have been replaced due to corrosion. All of the turbine furling dampers, which corroded to the point that the turbines would not unfurl, were replaced with appropriate corrosion proof dampers provided by BWC. Most of these maintenance activities occurred in 1996 under AWEA sponsorship.

However, by January 1998, only one wind turbine was actually generating power. UQROO, with some guidance from BWC and EyNT, rewound all of the turbines and replaced the permanent magnets in 1998. Thus, by late summer of 1998, five of the six wind turbines were once again providing power. Two turbines are in need of a some repair after a lightning event during the fall of 1998, and one turbine has blades that need to be rebalanced. Five of the wind turbine controllers require some repair at present.

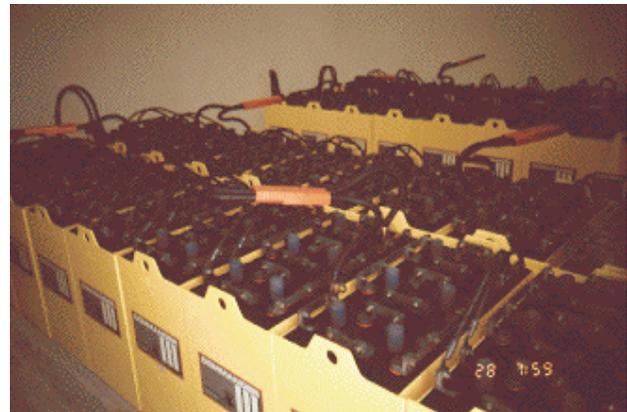
The GNB Resource Commander batteries have performed reliably since installation, this despite a hot climate and somewhat frequent and abusive charge and discharge cycles. The PV array helps maintain the battery bank charged when the wind turbines are off-line. One battery was randomly removed for dissection by GNB in 1994. The battery was found to be in excellent condition. Only one cell out of 216 cells has failed to date. It is difficult to quantify how much longer the seven-year-old battery bank will operate adequately, however the batteries are still functional.

Fig. 10. Battery bank for the Xcalak community.

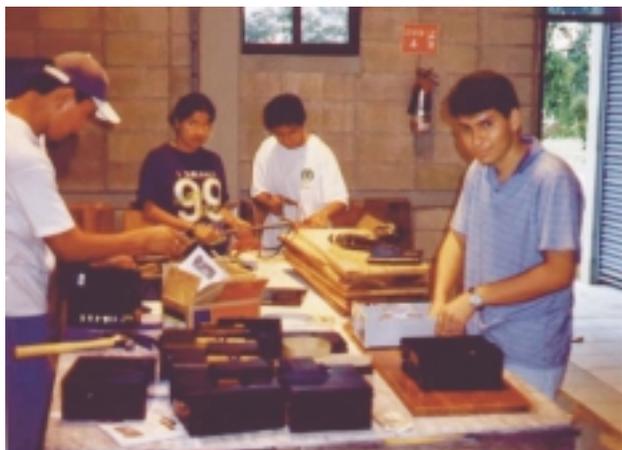
In May 1998, Energia Total completed a detailed analysis of the primary and secondary distribution system in Xcalak. Findings were that the primary system was capable of serving up to four times the existing load without significant voltage drop. However, low voltage found at several delivery points was due to poor secondary connections and inadequately sized service conductor.

Fig. 11. Universidad de Quintana Roo students pre-wiring meter base and load center in Chetumal (1999).

With funding support from NAFEC and NMSU, Energia Total recently lead a group of students from UQROO and village volunteers on a 14-day campaign to replace all existing service drop conductor to #6 or #8 AWG. They installed new #6 AWG service entrance conductor, new aluminium meter bases, new meters, and a new non-metallic load center with a minimum 20 Amp breaker at 100 service points within the village.

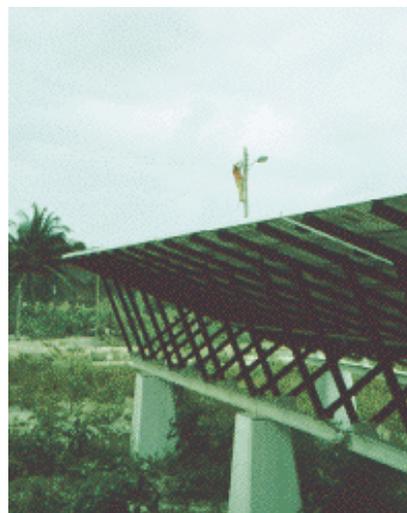
During the first two years of system operation, Condumex bore the responsibility for system operation and maintenance for the State. No individual kWh meters were installed, no bills were issued, and no revenues were collected during this period. In addition, more people were moving into Xcalak and hooking themselves up on the electric grid on their own. Eventually, a flat-fee tariff was implemented by an ad-hoc village electrification committee in 1996 to generate revenue for the purchase of diesel to serve the increased demand and compensate for declining renewables power availability.

Fig. 12. The man on the electric pole is conducting an unauthorized and home-made Xcalak grid connection (1994).
