LESSONS LEARNED FROM THE XCALAK VILLAGE HYBRID SYSTEM: A SEVEN YEAR RETROSPECTIVE

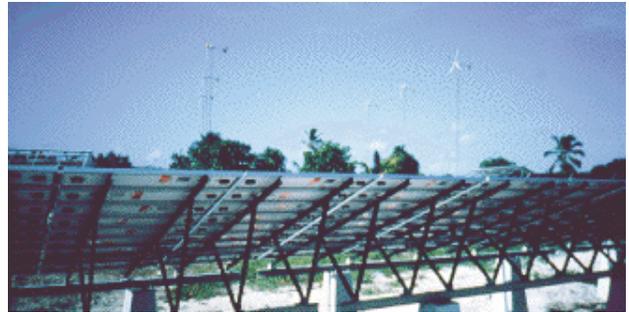
Fig. 2. Xcalak wind turbines and PV array.

The Xcalak hybrid system includes six BWC Excel 10 kW wind turbines. No special request or specification for anti-corrosive hardware was made by the system installer. Thus, it comes as no surprise that with continual exposure to salty air, corrosion and eventual failure of the wind turbines occurred. In 1998, all six wind turbines were lowered and locally rebuilt to the best of the abilities of the UQROO.

There have been other components that have had to be repaired, such as replacing the guy lines (the original galvanized ones had severely corroded after five years). Four turbine nose cones whose supports had rusted were replaced. The turbine tower disconnects and fuses suffered severe corrosion and were replaced in weatherproof enclosures. All of the furling winches and lines have been replaced due to corrosion. All of the turbine furling dampers, which corroded to the point that the turbines would not unfurl, were replaced with appropriate corrosion proof dampers provided by BWC. Most of these maintenance activities occurred in 1996 under AWEA sponsorship.

However, by January 1998, only one wind turbine was actually generating power. UQROO, with some guidance from BWC and EyNT, rewound all of the turbines and replaced the permanent magnets in 1998. Thus, by late summer of 1998, five of the six wind turbines were once again providing power. Two turbines are in need of a some repair after a lightning event during the fall of 1998, and one turbine has blades that need to be rebalanced. Five of the wind turbine controllers require some repair at present.

The Siemens M-75 PV modules have performed reliably and not suffered any problems. Minor corrosion is visible on some of the galvanized module frame screws. Module degradation in this hot and humid tropical climate has been

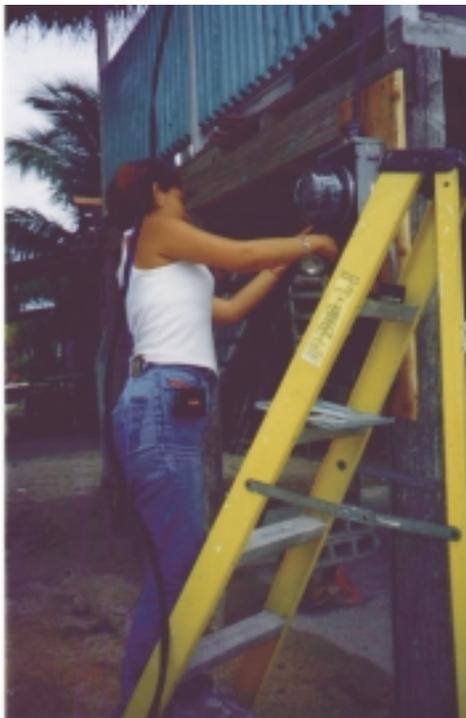
Fig. 13. Universidad de Quintana Roo student assisting with meter installations in Xcalak, June 1999.

of Xcalak. This effort took place in June 1999 and was supported by CFE with personnel and material assistance.

These meters provide a much-needed tool in the reconstruction of the hybrid system at Xcalak by providing a means through which a use-based energy tariff can be implemented and an operations and maintenance fund can be established.
